**MTR Adopts Improvement Measures after Lessons Learnt from
Kwun Tong Line Service Disruption on 5 August 2017**

Executive Review Panel Report on Signal Control Failure at Kwun Tong Station Area on 5 August 2017

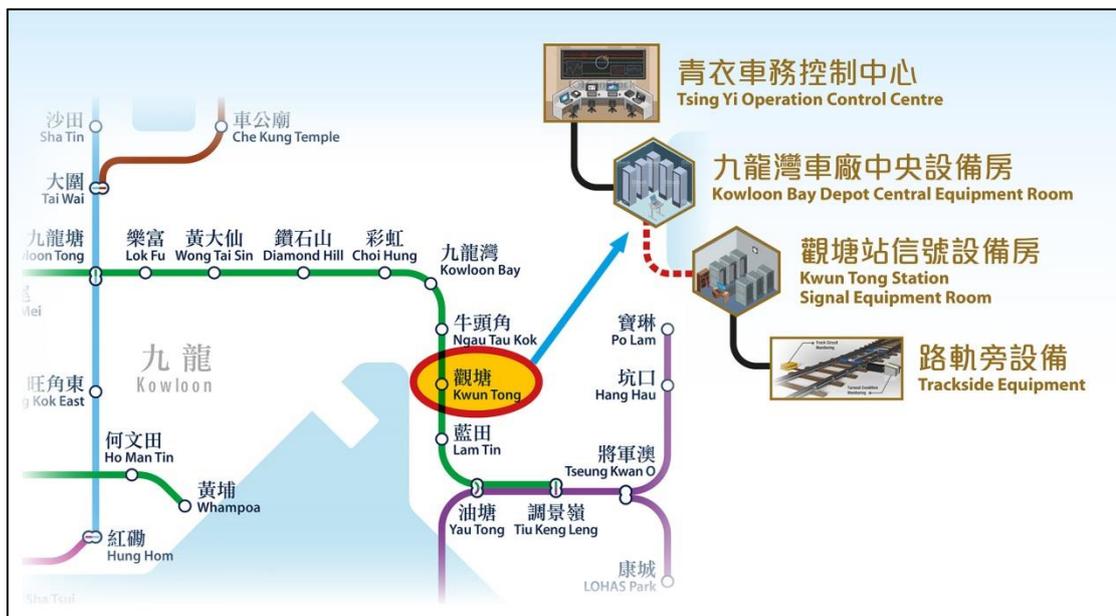
Diagram 6.1: Data transmission

- 6.1 The root cause of the incident was an intermittent open circuit in one of the two concurrent data transmission link cables. The two link cables provide redundancy in the signaling interlocking so that signaling control will work normally as long as one cable is working. However, the intermittent open circuit did not stop data transmission in that cable completely, but rather it caused intermittent loss or corruption of data. The resulting data corruption caused the KWT area interlocking system to automatically shut down according to the fail-safe design principle.

- 6.2 Each of the two data links consists of a twisted pair of copper cables that run along track-side in insulated sheaths. KWT signalling interlocking is the only interlocking in the MTR network that is still using copper cables as long distance data link between equipment rooms. All the rest use fibre optics. Although new systems will use fibre optics, copper cable is a well-established technology for data transmission. The KWT copper cables were originally planned to be removed when the KTL signalling system is replaced in 2020.

- 6.3 The intermittent fault was due to water ingress and corrosion inside one junction box of the copper cables. The corrosion of electrical contacts coupled with train movement vibrations caused intermittent short duration open-circuits, resulting in intermittent loss or corruption of data. As the inter-locking system detected inconsistent data set, it executed the fail-safe protocol and shut down all the 3 Multiple-Processor Modules (each module is like a computer), causing all trains in the affected interlocking area to stop. Such an intermittent cable fault had never happened in the KTL interlocking system in the past.

- 6.7 ***The Panel recommends to convert the KWT signal interlocking data-links into a fibre optic system before end of October 2017.***
