港鐵公司就東鐵綫服務事故提交報告

**Investigation Results on
Train Control System Failure on
East Rail Line on 11 January 2018**

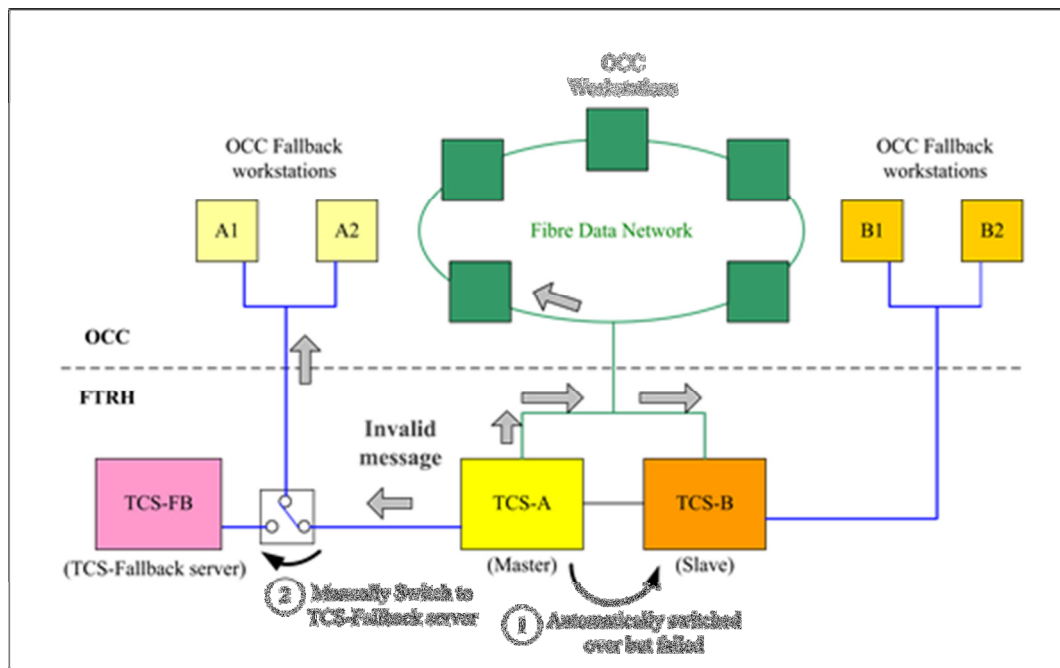
Figure 1: EAL TCS Servers and Workstations configuration

- 3.1 The existing EAL signalling system ensures train operation safety through the Automatic Train Protection (ATP) system and Solid State Interlocking (SSI) system. The two systems were intact throughout the incident, which protected train operation safety. Trains will be stopped automatically if any abnormality situation was detected. The unstable system involved in this incident is mainly for train service regulation purpose.
- 3.2 Currently, train service regulations on EAL are made by executing train regulation commands on the TCS at the OCC. It was revealed that just before the incident a controller at the OCC had executed a train regulation command, thereafter, the TCS operation became unstable.

- 4.1 Right before the failure on 11 January 2018, a controller had executed a specific train regulation command on the TCS. Subsequently, TCS-A sent out an “invalid message”, which triggered situational software issue, resulting in the halting of all the workstations at the OCC as well as TCS-A due to surge use of its software memory resources.

- 4.2 Detailed investigation with experts from the signalling equipment supplier together with the TCS simulator server built to facilitate fault diagnosis and software testing confirmed that the failure was due to a hidden software coding error in the software application module of that specific train regulation command that had been applied right before the incident. It was also confirmed that the concerned command is the only command among all in the TCS software which may trigger the “invalid message” problem when being executed.

- 4.3 Because of such hidden software coding error, the actual execution time of this command would depend and be prolonged with respect to the ever traffic demand changes over the years resulting in more complex timetable, and also the situational software memory resources level. When the execution time reaches a threshold set in the software code, it will trigger the “invalid message” problem. Such execution time prolongation and its threshold limit built in the software was not known to MTR since day one revenue service of TCS system in 2003 noting the traffic demand has been kept on increasing over the years.
