MTR Submits Report on East Rail Line Train Service Disruption

**Investigation Results on
Train Control System Failure on
East Rail Line on 11 January 2018**

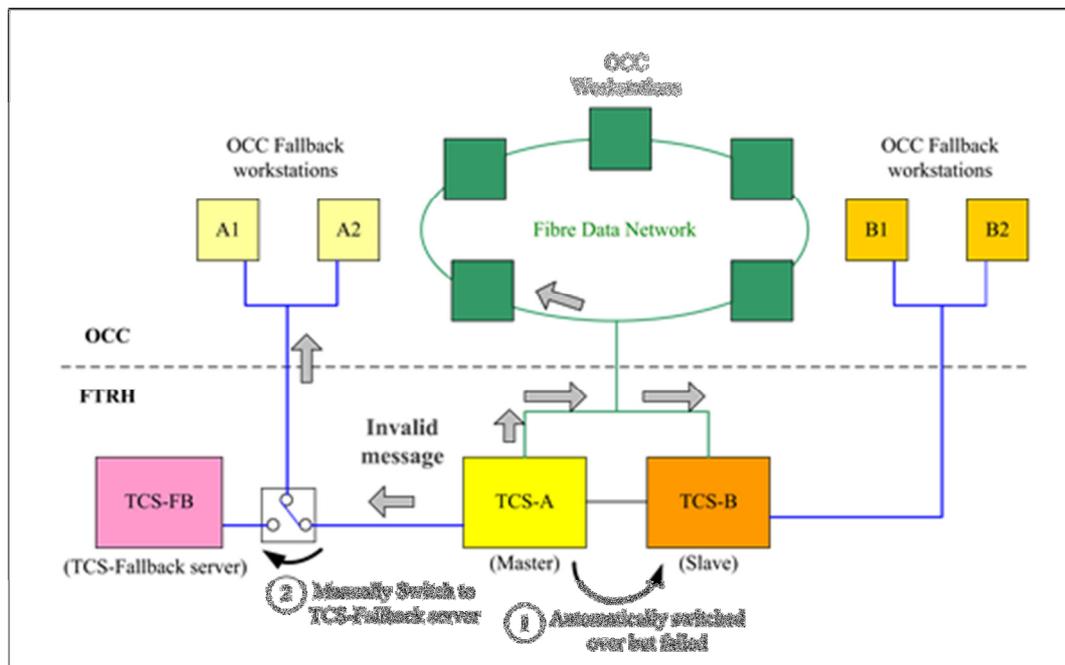
3.3 It was identified in subsequent investigation that TCS-A sent out an “invalid message” after the controller had executed the concerned train regulation command, which triggered a situational software issue. It resulted in the halting of all the OCC workstations including the fallback ones at the OCC as well as TCS-A due to surge use of its software memory resource. Figure 1 below shows the TCS servers and workstations configuration during the incident.

Figure 1: EAL TCS Servers and Workstations configuration

- 3.4 At the beginning of the failure, the system automatically switched over the server from TCS-A to TCS-B, but the system failed to recover with sluggish response because TCS-B was busy performing synchronization of trackside signalling status with the SSI and responding to the workstations rebooting.
- 3.5 The technical team had to manually switch over the server to TCS-FB while carrying out a few attempts to reset TCS-A and TCS-B servers. It took more time than expected because the fallback workstations were also disturbed by the “invalid message”, which needed to be rebooted.
- 3.6 The system eventually resumed normal operation at 1021 hours after the TCS-FB server and fallback workstations had been activated successfully.

- 4.1 Right before the failure on 11 January 2018, a controller had executed a specific train regulation command on the TCS. Subsequently, TCS-A sent out an “invalid message”, which triggered situational software issue, resulting in the halting of all the workstations at the OCC as well as TCS-A due to surge use of its software memory resources.

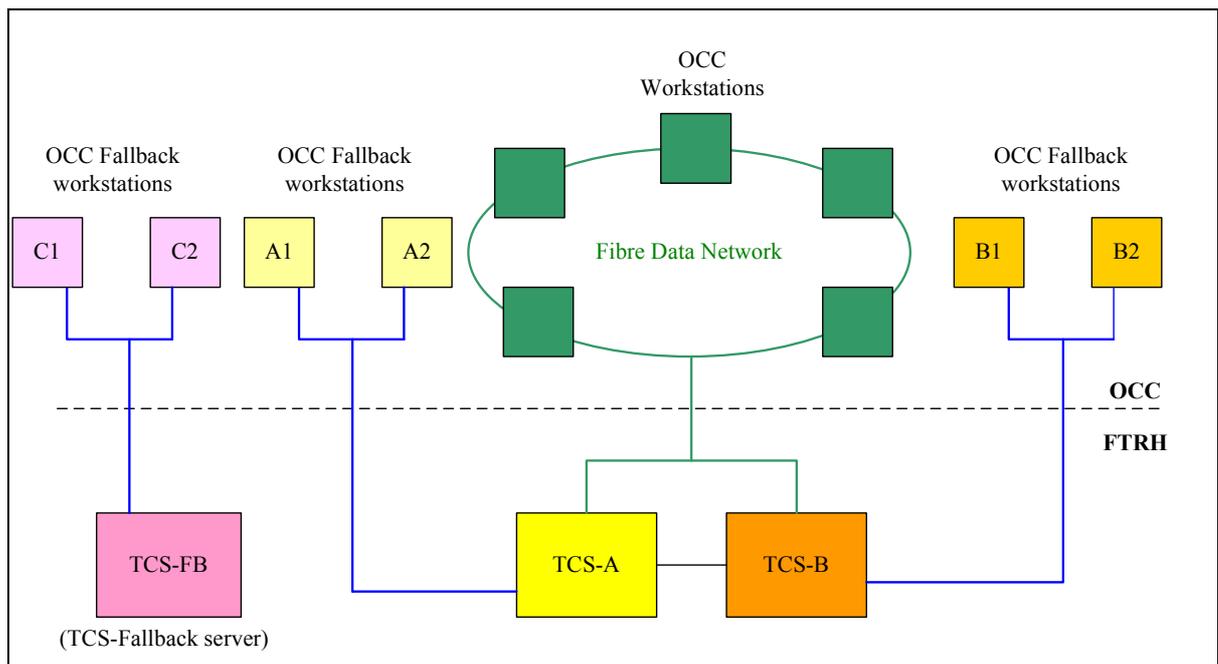
Figure 2: EAL TCS Servers and Workstations enhanced configuration

- (ii) The recovery procedure has been further enhanced to ensure more effective recovery process in case of TCS failure including this new failure symptom.
- (iii) The TCS fallback workstations have been completely isolated from TCS-A and TCS-B to avoid disturbance by whatever software issues so as to ensure quick manual start-up whenever necessary. Figure 2 below shows the enhanced TCS servers and workstations configuration.
- (iv) Round-the-clock monitoring of the TCS performance and its software memory resources level has been carried out to enhance responsiveness to any abnormality and recovery need.
- (v) The frequency of TCS software restarting in non-traffic hours has been increased as an additional preventive measure.
