**MTR Adopts Enhancement Measures after Service Disruption
on Tsuen Wan Line, Island Line, Kwun Tong Line and Tseung Kwan O Line**

**Executive Review Panel Report
on the Signalling Failure on the Tsuen Wan, Island,
Kwun Tong and Tseung Kwan O Lines
on 16 October 2018**

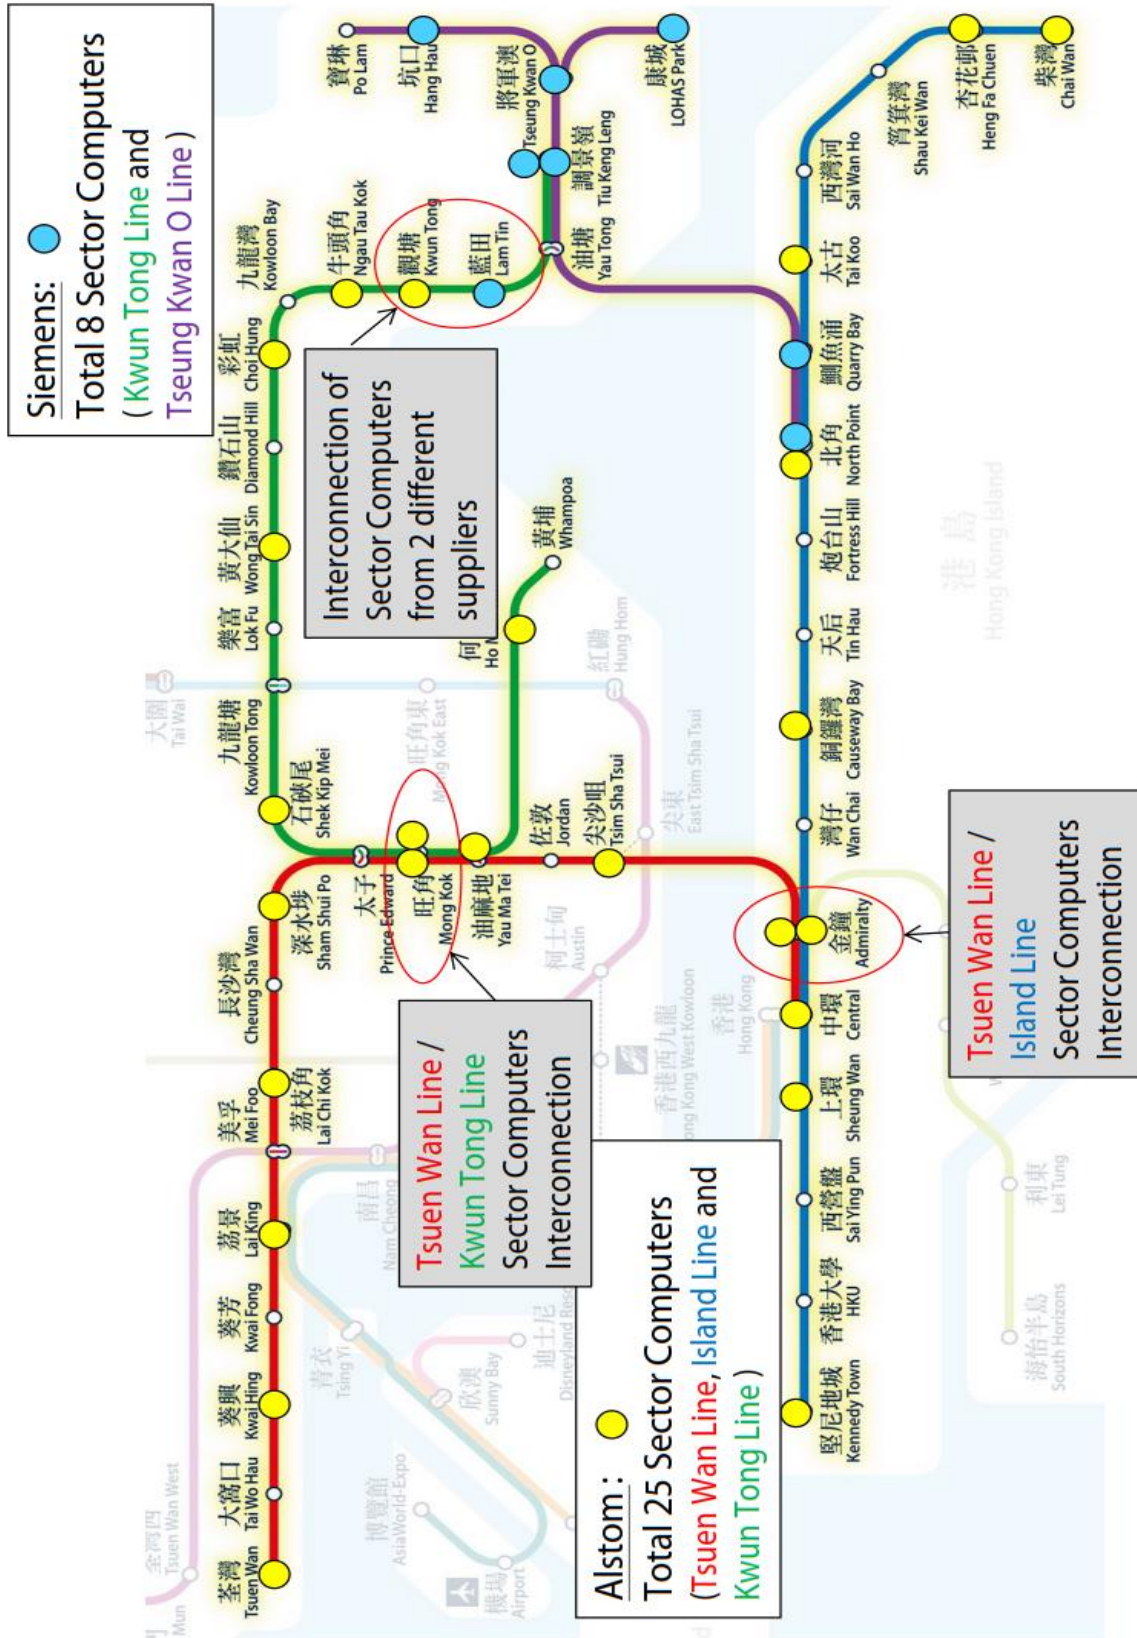
Figure 1 - Configuration and Interconnection of Sector Computers

- 5.1.2 The Alstom system is equipped with 25 sector computers and has been in use since 1996 (including two sector computers for ISL extension and KTL extension that were put into service in 2014 and 2016 respectively). The Siemens system covered 8 sector computers and has been in use since 2001 and 2002 respectively. The sector computers are located in the Signal Equipment Room (SER) at stations and serve to deliver train control commands to all trains in each respective sector. The sector computers for each line are interconnected by Inter-sector Links to manage trains running between sectors. There are also interconnections between lines to allow trains to cross between lines to optimize train service when there is an operational need. The two suppliers' sector computers are linked between KWT (Alstom) and LAT (Siemens), i.e. along the KTL (refer to Figure 1 in the appendix).

initialization while the Siemens sector computers continued counting up, creating an inconsistent re-initialization situation between the two interconnected sector computers at KWT (Alstom) and LAT (Siemens). This resulted in repeated execution of re-initialization followed by re-synchronization with the higher counter figure from LAT, in the KWT sector computer in an endless loop causing corresponding instability in all 25 Alstom sector computers in the system.
