**MTR Strengthens Monitoring over Contractor of New Signalling System as Software Implementation Errors were Identified as Causes of Tsuen Wan Line Incident on 18 March 2019**

**Executive Summary**

### Incident of the New Signalling System Drill on Tsuen Wan Line on 18 March 2019

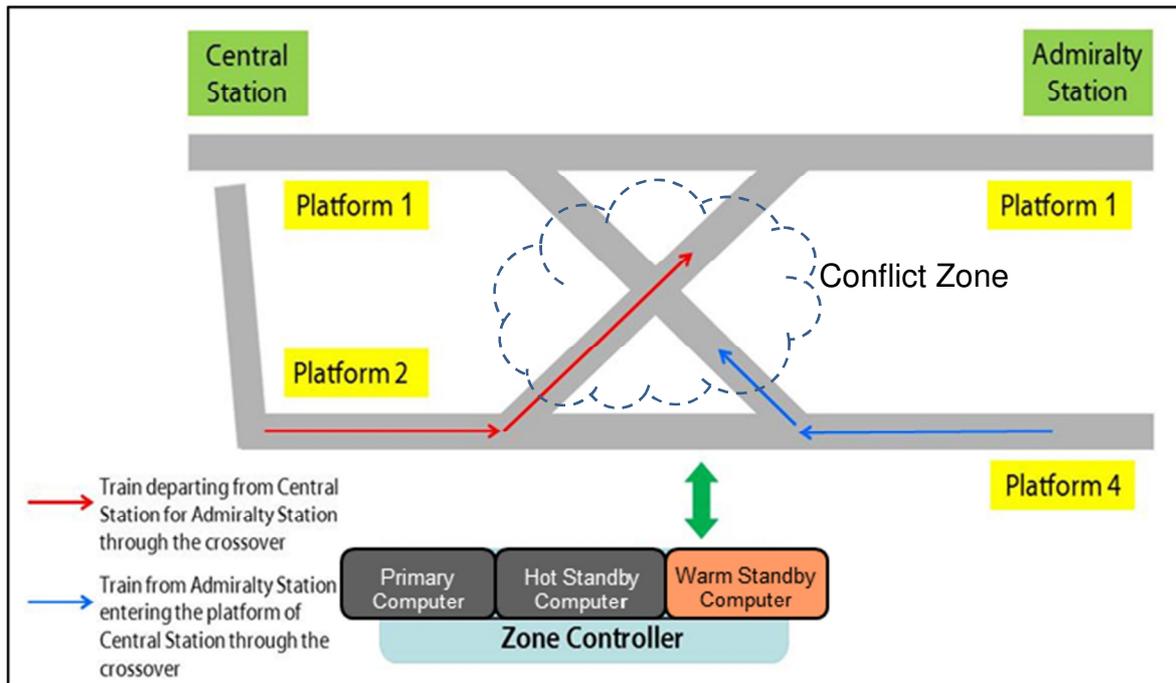
## Annex 2

- 4.3 At around 02:41:32 hours, the TC gave a “Depart” command to the train berthing at CEN platform 2 in accordance with the procedure. The route for the train to go to ADM platform 1 was then set by Computer C. At around 02:43:53 hours, for normal traffic regulation, the TC disengaged the platform sequencing selection for CEN to allow the waiting train to berth at CEN platform 1 which was vacant. At around 02:44:01 hours, Computer C erroneously set conflicting routes with signal clear, causing the two trains departing within seconds in Automatic Mode to collide at the crossover outside CEN. For such an instantaneous and unexpected system behaviour, it was very challenging and difficult for the TC to respond and intervene at OCC level through the execution of command steps in calling the emergency brake of the trains in time, as the role of the TC was to manage train regulation activities and as such they would not be expected to be checking for and reacting to such unexpected system behaviour. Similarly, although the Train Captain of the train travelling to CEN platform 1 did activate the emergency brake when he saw the train travelling from CEN platform 2 to ADM platform 1, the train was not able to stop before colliding.

The diagram at Annex 2 illustrates the scenario.

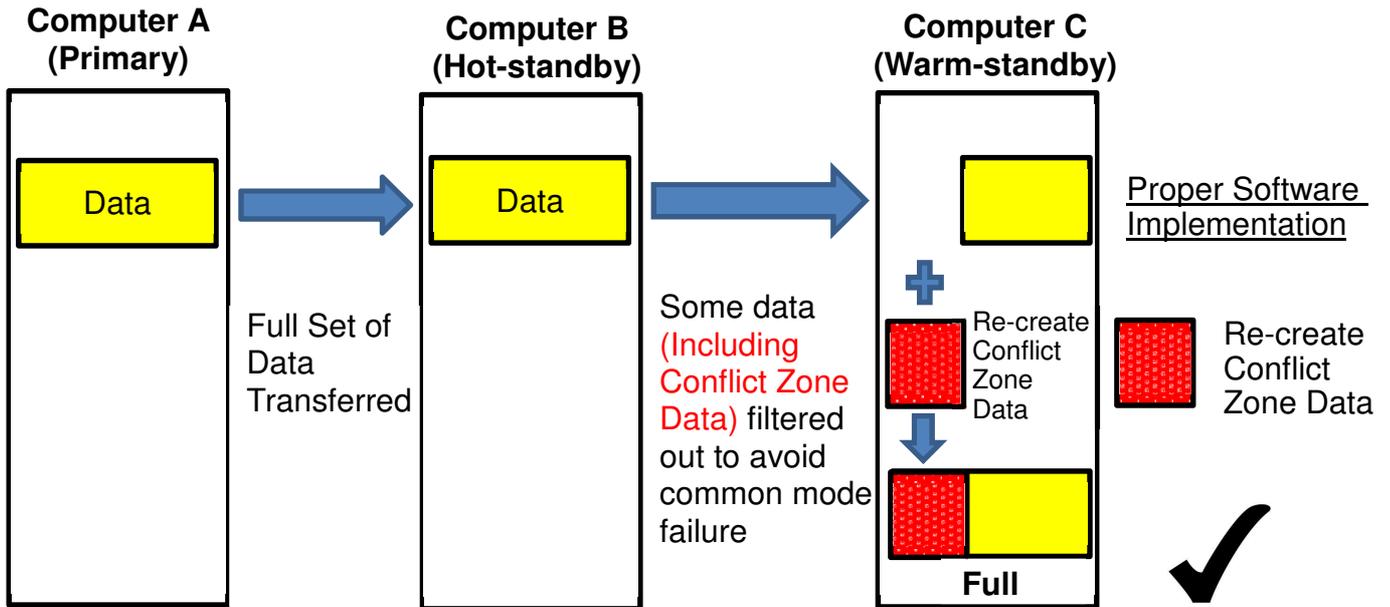
#### Design Intention developed by ATDJV

- 5.2 To avoid common mode failure according to the contract requirement, ATDJV thus initiated a software change in July 2017. Some dynamic data was selected to be excluded (including “Conflict Zone Data” which prevents conflicting routes from being set) from the data transferal from Computer A/B to Computer C, and those excluded data should subsequently be re-created internally in Computer C. The amount of data excluded and re-created was determined by ATDJV with due consideration to the risk of common mode failure and the swift recovery time so required for Computer C to take up as the Primary Computer in case both Computer A and B fail. However, this software change initiated by ATDJV gave rise to a software issue due to a series of software implementation errors made by its software design and development team during the process of performing this software change.

On 18 March, Computer A as “Primary” was switched off and made Computer B become “Primary”, thereafter, Computer B was subsequently switched off and made Computer C become “Primary”.

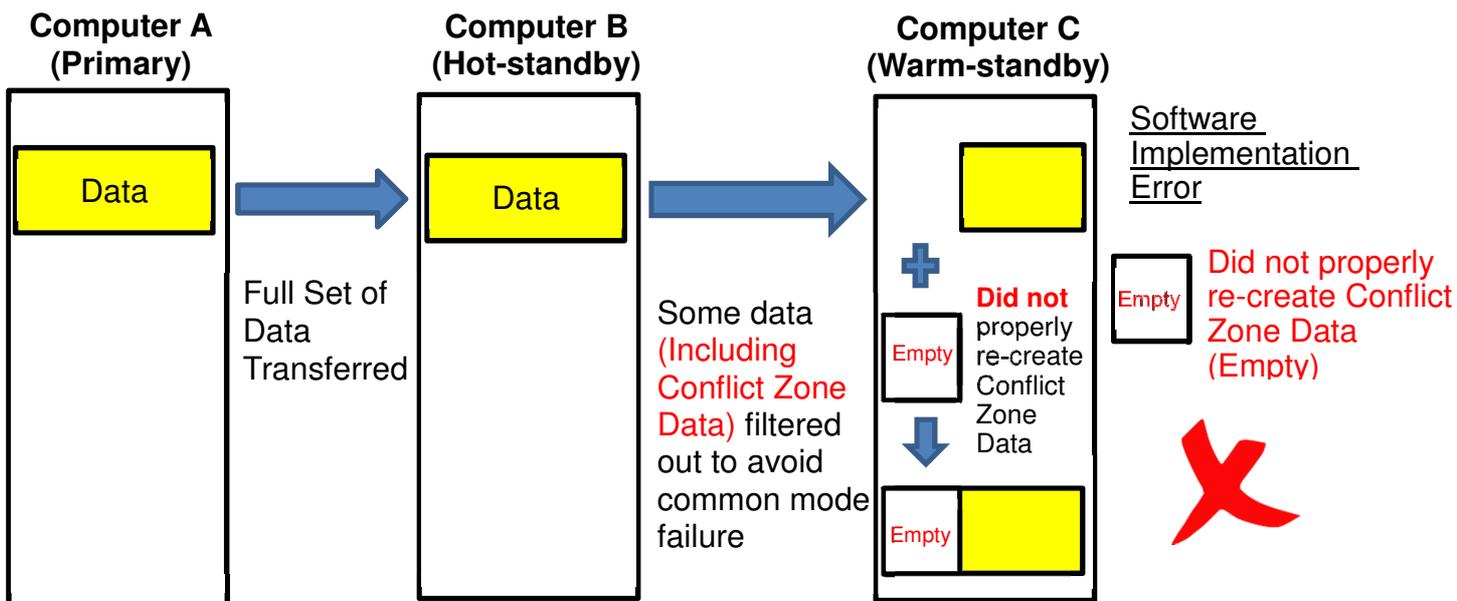
#### What Happened :

- 5.3 Investigation revealed that ATDJV had created the software issue which was caused by the following three software implementation errors made during the process of performing this software change. First, while “Conflict Zone Data” was meant to be excluded, out of expectation it was not specified in ATDJV’s internal software development document. Because of this lack of specification, no subsequent specific test, risk assessment and safety analysis, including laboratory verification simulation and on-site testing, was done by ATDJV to verify the “Conflict Zone Data” when Computer C took over as the Primary Computer. This was the first software implementation error.

- 5.4 Second, ATDJV excluded the transfer of the “Conflict Zone Data” from Computer A/B to Computer C, but its software design and development team made a software implementation error in failing to properly re-create the “Conflict Zone Data” internally in Computer C. This second software implementation error resulted in there being no “Conflict Zone Data” when Computer C took over as the Primary Computer.
- 5.5 Third, the software logic so built by the software design and development team did not stop Computer C from taking over as the Primary Computer when “Conflict Zone Data” was not available; in other words Conflict Zone protection was not available. This is considered as a software implementation error in not implementing appropriate programming logic to prevent Computer C from taking over as the Primary Computer while having no conflicting route protection.

- (a) software development document did not specify the exclusion of the “Conflict Zone Data” which led to no ensuing specific test and safety analysis to identify the unknown software issue;

- (b) a software implementation error led to no re-creation of proper “Conflict Zone Data” internally in Computer C when Computer C took over as the Primary Computer; and

- (c) while Conflict Zone protection was not available, subsequently Computer C still continued its process to become the Primary Computer because the software logic was so built that it did not stop Computer C from taking over as the Primary Computer, resulting in missing the conflicting route protection.

Software Implementation Errors resulted into an unknown software issue

- (a) replace the software design and development team causing the software issue;
  - (b) fix the software change issue and confirm with substantiation that there are no wider implications in software development quality;

- (c) enhance the software coding and testing practices to avoid future programming errors and introduce effective and traceable measures for detection of any programming errors; and

- (d) develop a full range of effective measures, including but not limited to (i) employing an external Independent Software Assessor to enhance the software development process for Computers A/B and C from its core product; (ii) reviewing, re-checking and demonstrating robustness on its approach with traceable evidence in applying a fail-safe principle; and (iii) conducting risk assessment in its software implementation with support from the Panel's experts.
