PR018/20
3 March 2020**MTR Implements Improvement Measures as Investigation Panel Concludes Dynamic Track Gauge Widening Caused East Rail Line Derailment Incident**

Executive Summary

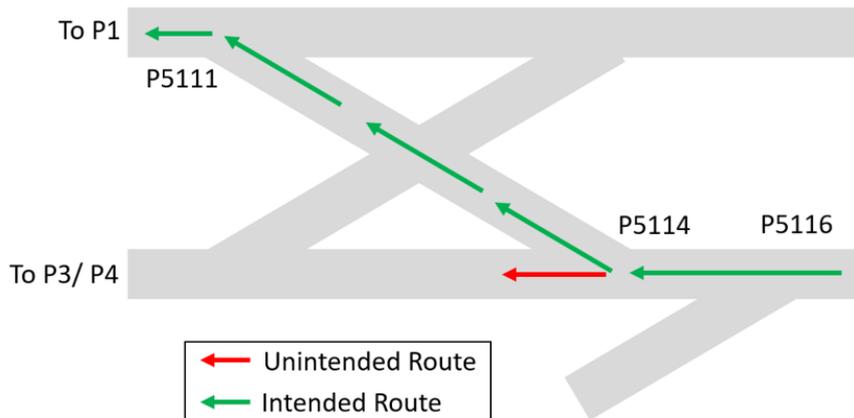
Annex 2

- 4.2 At about 08:29 hours, the leading wheelset of the 5th car of Train 1 rode up on the remainder of the damaged check rail of turnout P5116 and took an unintended route towards Platforms 3 and 4 at turnout P5114 as shown in Annex 2, completely derailing the 4th, 5th and 6th cars and dividing the train between the 4th and 5th cars at a speed of around 39km/h.

Illustration of Train Route (Intended/ Unintended) of Train 1

The Incident train, Train 1 travelled on diverged route at turnout P5114.

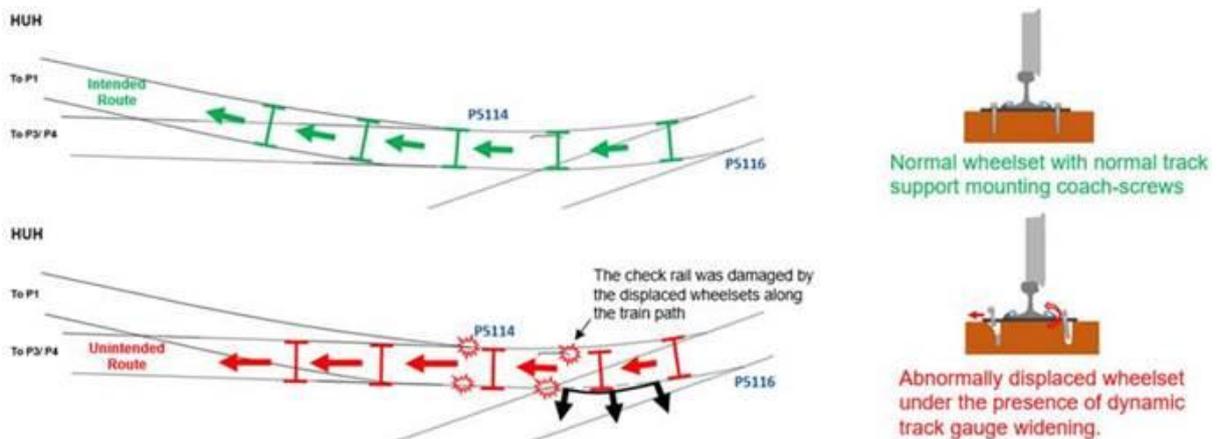
- 4.1 Prior to the incident, at about 08:18 hours on 17 September 2019, the leading wheelset on the 8th car of Train number L086 [hereafter "Train 5"] hit the check rail of turnout P5116 and damaged it as shown in Annex 2. A check rail is laid parallel to a running rail to guide wheels through the rail crossing of all turnouts. The wheels of 3 subsequent trains [namely "Trains 4, 3 and 2"] hit and progressively further damaged the check rail but still took the

- 4.3 The wheelset of Train 5 damaged the check rail due to widening of the dynamic track gauge (the distance between the rails under the load of a running train) beyond a critical level.

What Happened:

The immediate cause of the derailment was due to dynamic track gauge# widening at turnout P5116.

(#the distance between the rails under the load of a train)

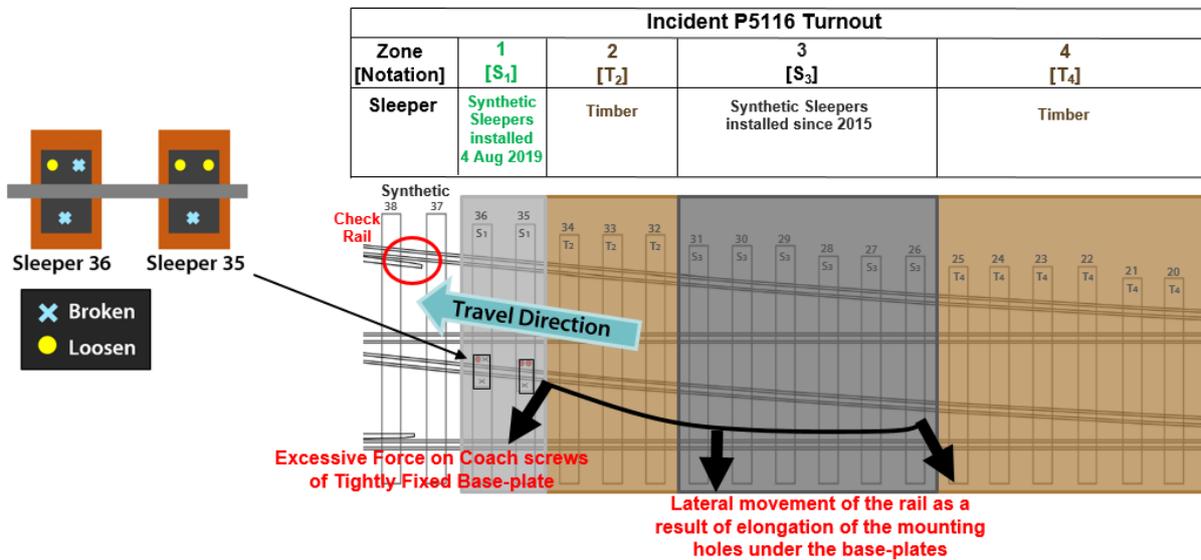
Annex 3

- 4.4 This dynamic gauge widening was initiated by:
- a) lateral movement of the rail in the group of 6 synthetic sleepers (Zone 3 in Annex 3) immediately preceding the group of 5 deteriorating timber sleepers (Zones 1 and 2 in Annex 3) in front of turnout P5116 as a result of loosen/broken coach screws and elongation of the mounting holes under the baseplates. This prevented them from taking up their fair share of the lateral force resulting from train operation;

- b) the subsequent localized uneven lateral track stiffness introduced after the replacement of 2 (Zone 1 in Annex 3) of the group of 5 deteriorating timber sleepers on 3rd August 2019; then

- 5.1 There was an array of 17 sleepers preceding the check rail of P5116 as shown in Annex 3:
- a) Zone 1: Two original timber sleepers replaced by synthetic ones on 3rd August 2019;
 - b) Zone 2: Three original timber sleepers;
 - c) Zone 3: Six synthetic sleepers that replaced the original timber sleepers in 2015; and
 - d) Zone 4: Six original timber sleepers.

- 5.4 The combination of the uneven localized track lateral stiffness over the sharp curve comprising of the 4 zones within the turnout P5116 eventually resulted in excessive lateral force on the rail at the 2 newly replaced synthetic sleepers at Zone 1, causing the coach-screws to break under load.

Illustration of Sleeper Arrangement at Incident Turnout P5116

Timber sleeper (2 nos.) replacement at Zone 1 on 3rd August 2019 to correct the track gauge had resulted in developing excessive force breaking the coach screws.

- a) Develop measures to address the variation in lateral stiffness when using synthetic sleepers in replacing timber sleepers to avoid prolonged stress concentration on individual coach screws. (Completed);

- b) Accelerate the planned replacement of 2,627 East Rail Line timber sleepers to give extra performance resilience to track integrity. (To be completed by mid-February 2020);
