**MTR Announces  
Launch of East Rail Line New Signalling System and 9-car Trains on 6 February and  
a Series of Measures to Enhance Shatin to Central Link Project Control**

**Investigation Panel Report  
on Route Recall Issue**

**Date: 8 December 2020**

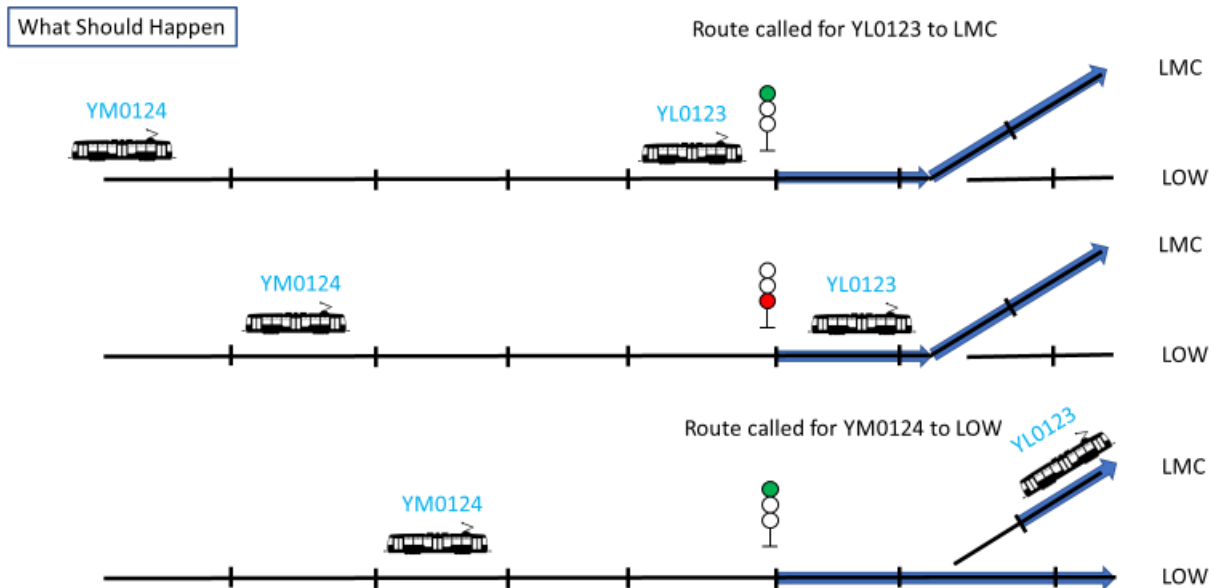
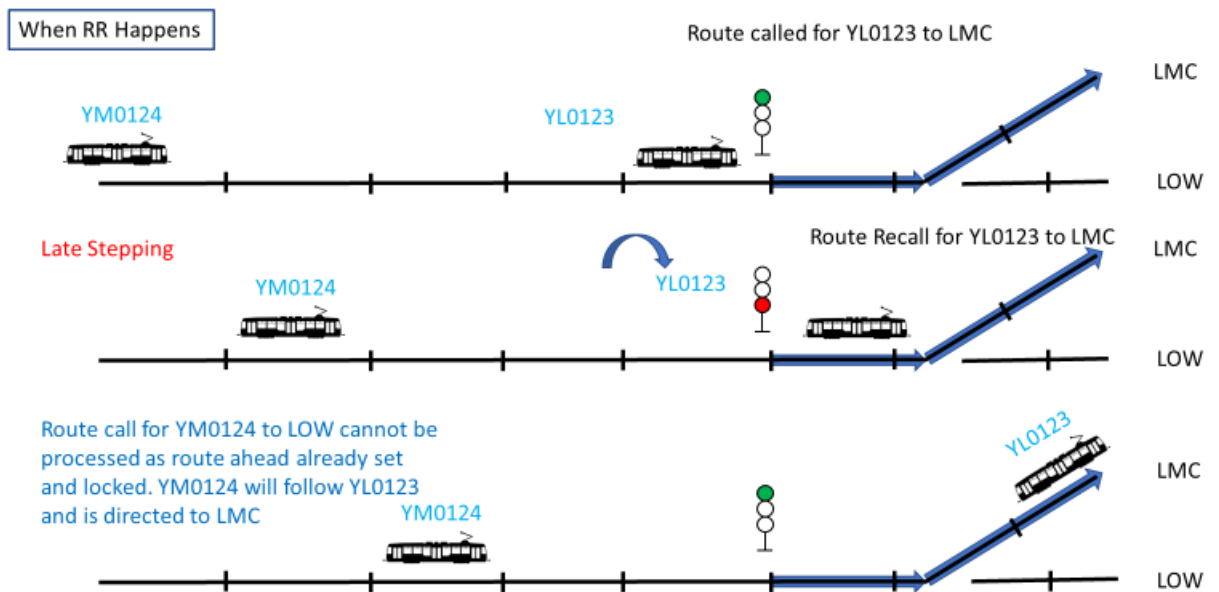
3.1 *Initial discovery:* As part of the process to satisfy itself of the safety and soundness of the new signalling system and MFO (hereafter referred to as “the project”), MTRCL conducted extensive testing during NTH. The RR issue was first noted in an NTH test on 11 May. When a train that has already been given a route by the Automatic Route Setting (ARS) system physically moves past a signal, the route should be released. However, if the virtual representation of the train lags slightly behind its actual position (this phenomenon is termed “late stepping”) RR could occur. The virtual representation of trains is tracked and reported by a sub-function, Train Monitoring and Tracking (TMT) of the Automatic Train Supervision (ATS) system. When a ‘late stepping’ issue happens, the ARS sets or “re-calls” the identical route, which can be picked up by the following train.

- 3.2 A RR issue can lead to a “deadlock” situation when a number of trains cannot continue along their path, because they are blocked by another train. At bifurcations and at stations with multiple platforms, an RR issue could potentially lead to a train taking the wrong route. There are no safety implications as the signalling safety sub-systems would maintain the safe separation of trains and prevent collisions even if a train took the wrong route. However, a RR issue may result in service disruption or passenger inconvenience through a delay of service or, train movement along an unintended route, even though safety is protected throughout the whole movement.

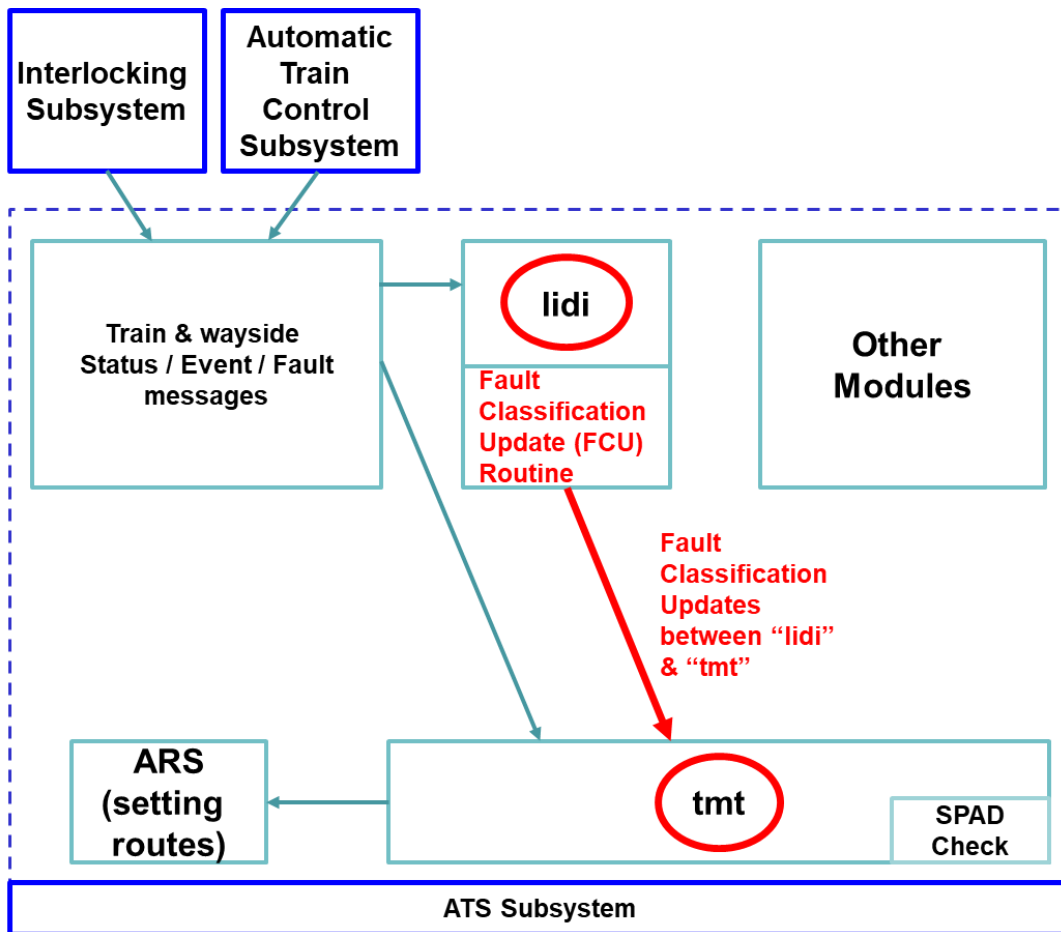
## Annex 2: TMT Data Processing between ATS modules “lidi” and “TMT”

The new TMT Data processing for “fault classification updates” messages made between the ATS module “lidi” and “TMT” as shown below, is a new and project specific feature tailor-made by the Contractor to fulfill the MTRCL’s requirement.

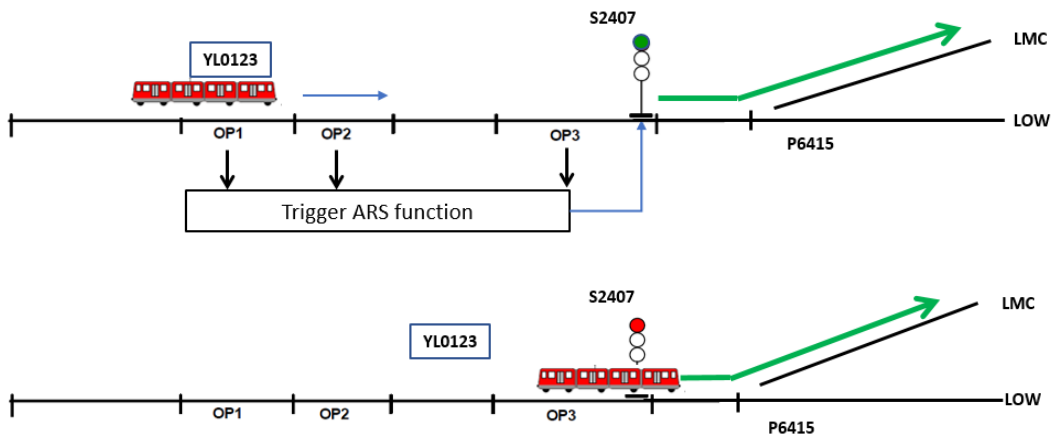
### 3. TD Stepping Delay and RR issue

When the TMT CPU is overloaded as revealed in the investigation, the “TD stepping” could be delayed and hence the TD location of the preceding train YL0123 in the above would be lagging behind the physical train position. As a result, the TD is located behind the train as shown below.

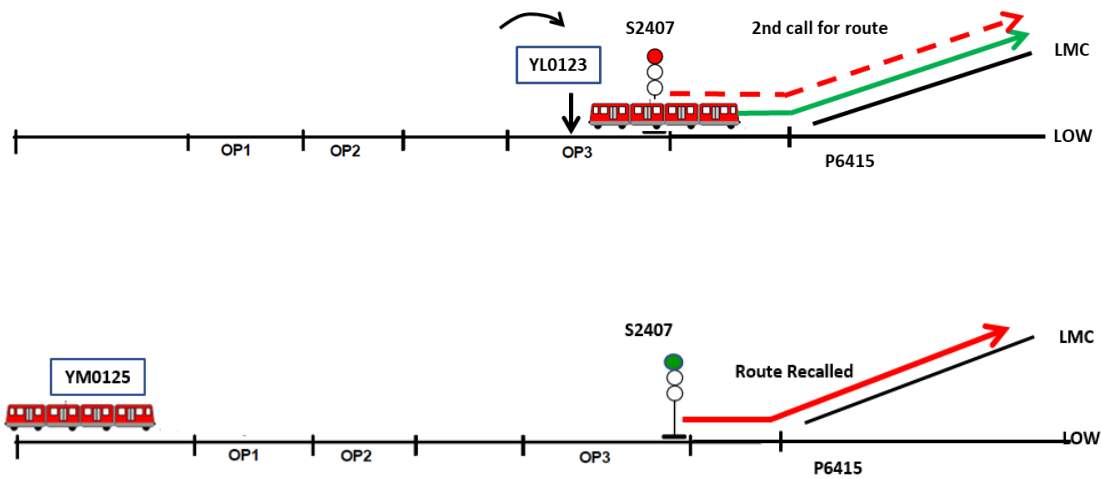
### 4. Consequence

Since the TD is located behind the train, even after the train has passed the signal and turned the signal to stop (Red) aspect, the ARS re-calls the route again when the delayed TD steps on OP3, as illustrated below. Such would lead to recalling of the same route as that of the

preceding train (YL0123), for this example, with destination of Lok Ma Chau (LMC) for the next train, and hence the following train (YM0125) may pick up the recalled route and go to its unintended destination. As illustrated in diagram below, the following train (YM0125) with original destination at Lo Wu (LOW) might be unintentionally routed to LMC.

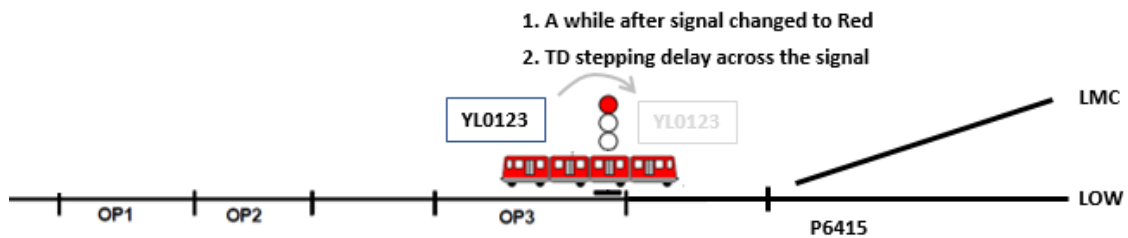
Another side effect is, subject to the extent of the delay “TD stepping”, false SPAD alarm may be resulted in TMT processing when the delayed TD steps across a red signal:

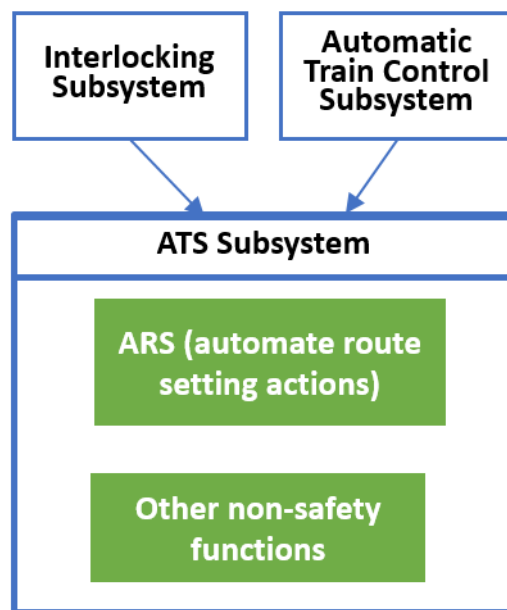
## 5. Safety functions remain intact

Route Recall Issue is not a safety related issue because the ARS is a non-safety related function provided by the ATS subsystem. The safety checks provided by the Interlocking subsystem and Automatic Train Control subsystem (including Automatic Train Protection i.e. ATP) as below, for route setting and train separation remain intact, i.e. all safety functions use the physical train locations and not the Train Descriptors to maintain a safe separation between trains. The ATP always monitors the physical position of the train to ensure that adequate safety distance is maintained between trains; and if not so maintained, the ATP will apply emergency braking.
