Press Release

PR004/23
12 January 2023

MTR Fully Implementing Recommendations about Enhanced Maintenance Regime and Contingency Arrangement following Train Incident at Yau Ma Tei Station

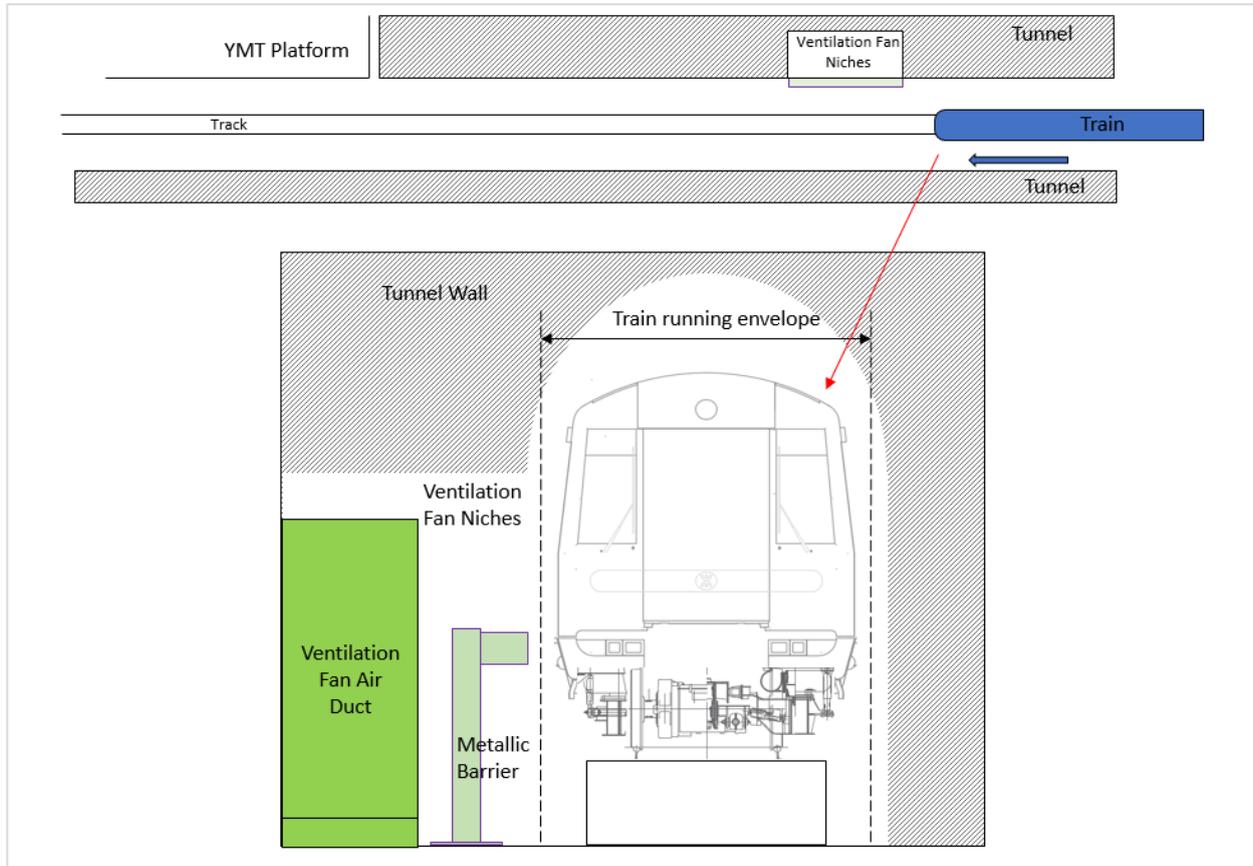
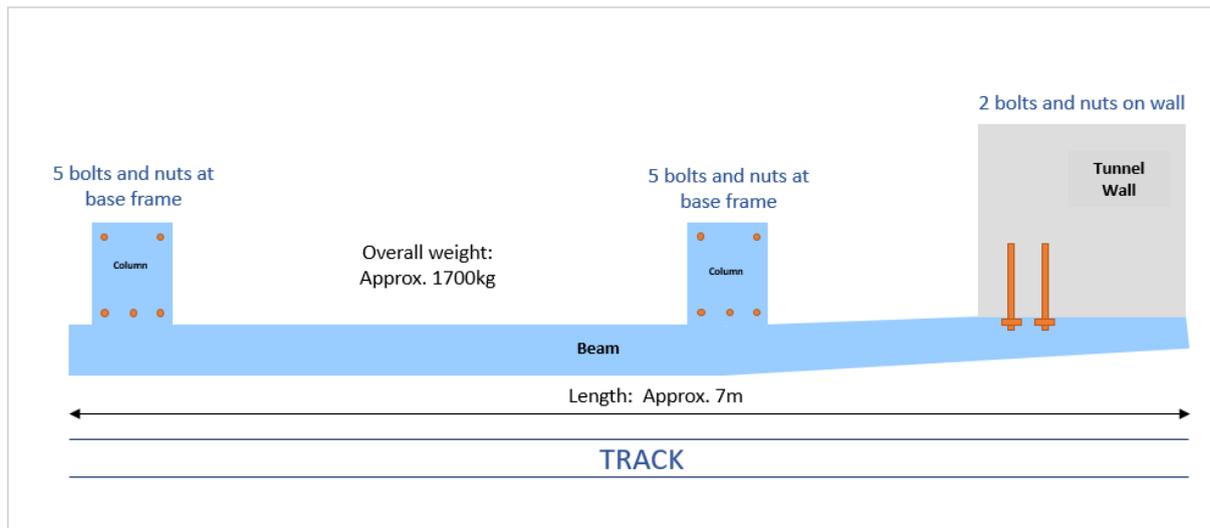
Illustration of metallic protection barrier

- 4.4 Post incident inspection on the incident metallic protection barrier revealed serious corrosion at its twelve mounting bolts and nuts with five at each of the two base frames on the ground and two on the tunnel wall as illustrated in Annex. Corrosion wastage was apparent above the two base frames each with five mounting bolts and nuts, while with more extensive corrosion at the unexposed cavities inside the base frames and its mounting bolts, resulting in loss of mounting grip of the bolts to the ground. The loss of mounting grip led to structure instability and as the two corroded mounting bolts on the tunnel wall eventually broke, the protection barrier leaned over and intruded into the path of the train.

- 5.2 The cause of mounting corrosion of the metallic protection barrier was investigated. Based on technical investigation with external experts, a more concentrated corrosion occurred around the middle portion of the mounting bolts right between the interface of the base frame and mortar. Corrosion in such unexposed interface took place significantly faster than those in the exposed regions due to effects such as differential local reduction of oxygen concentration and stress on the bolts.
- 5.3 Site inspection revealed that there were significant corrosion related deposits and considerable water seepage along the tunnel walls near the incident site. Post investigation testing of water sample at the incident site revealed rich amount of chloride in the water and high electrical conductivity, both of which would lead to accelerated rates of iron corrosion.

- 5.5 Detailed technical investigation with external experts revealed that the accelerated metal loss of the mounting bolts caused by corrosion attack from surrounding water with aggressive environmental properties led to loss of integrity of the mounting. The Panel is of the view that for barriers in such aggressive environmental condition, design enhancement shall be re-examined, such as mounting the barrier on raised plinth or with enhanced corrosion protection measure, etc. In addition, the consequence of intruding into the train path due to its falling risk should be assessed and designed out at the time when it was introduced in 1978, i.e., it should not lean to the trackside and intrude into the train path if it falls.

- a. Enhance the civil structure maintenance regime with specific maintenance given to all the metallic protection barriers <Completed>
- b. Enhance all metallic protection barriers of similar nature through upgrading or complete replacement <by May 2025>
- c. Complete a comprehensive trackside infrastructure and
