#### **MTR Fully Implementing Improvement Actions following Train Incident on Tseung Kwan O Line**

## **Executive Summary**

## Annex – Illustration of the Energy Absorption Device

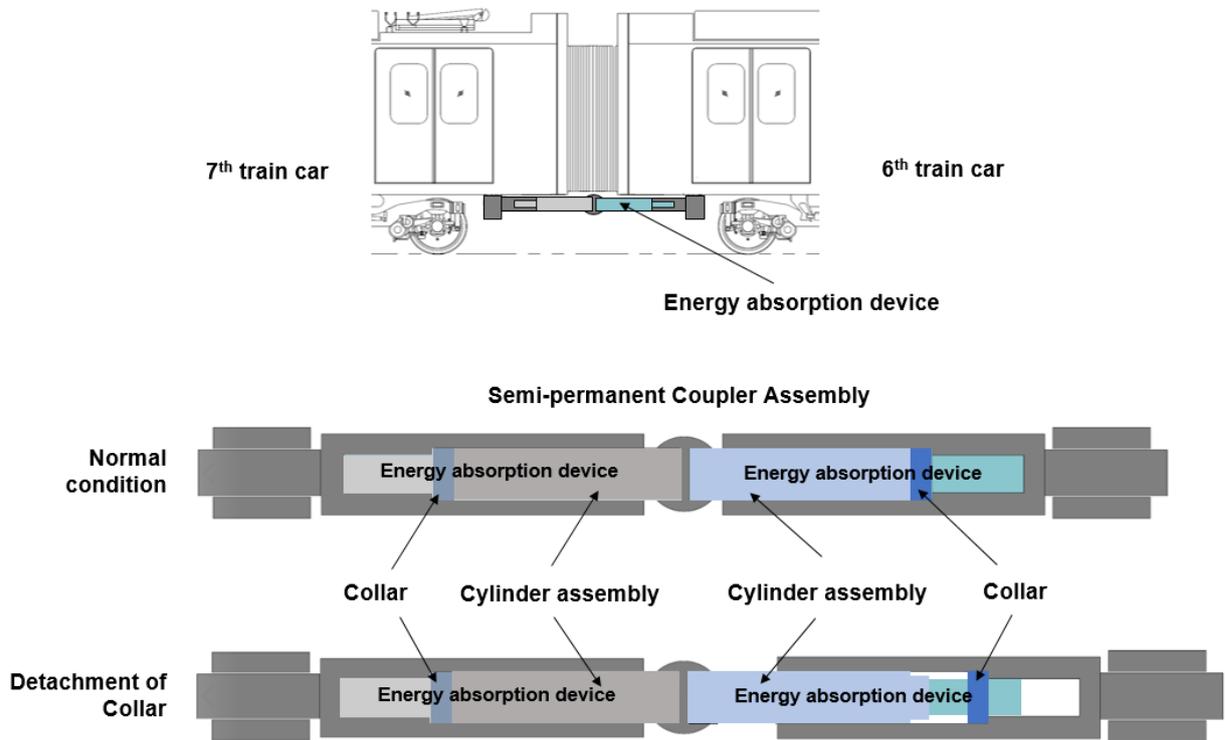
- 4.2 Post incident inspection on the incident device revealed that its collar was detached from its cylinder assembly. Extensive investigation with the coupler assembly supplier and the OEM of the energy absorption device was conducted with the support from the external specialists. It was concluded that the most credible cause of the detachment of the collar was due to ineffective application of the Loctite adhesive on its screw thread at its original build, as evidenced from the subsequent chemical analysis of the residuals left on the collar. As a result, the locking mechanism was weakened and eventually failed to withstand the

- 6.12 Based on the evidence obtained and the support from the external specialists, the cause of the detachment of the collar from the cylinder assembly internally was due to ineffective application of the Loctite adhesive on its screw thread at its original build, as evidenced from the subsequent chemical analysis of the residuals left on the collar. As a result, the locking mechanism was weakened and eventually failed to withstand the rotation force acting on it during train operation over the years.
- 6.13 The other possible factors including usage, maintenance arrangements, and overhaul process by OEM were considered not contributory to the incident.

- a. Install two additional lock pins on the existing collar for the fleet as per the advice of the device's OEM to give extra security before fleet-wide replacing them with an enhanced one-piece cylinder design without collar. <by end of February 2023>
- b. Require the supplier to replace the incident type energy absorption devices designed with collar by an enhanced one-piece cylinder design without collar. <by Q1 2025>
- c. Explore with the coupler assembly supplier on tools to monitor the performance of the energy absorption device, including application of technology. <by mid 2024>
- d. Enhance passenger information dissemination at stations through QR Code <by March 2023> and conduct review for enhancing S-bus route arrangements during incident, with due consideration of connecting to alternative train routes and other modes of transportation <by June 2023>.
