PR046/25  
27 June 2025

#### **MTR Implements Eight Follow-up Actions Targeted Asset Inspection in Progress and Strengthening Community Collaboration to Provide Better Support to Passengers**

## **1 Executive Summary**

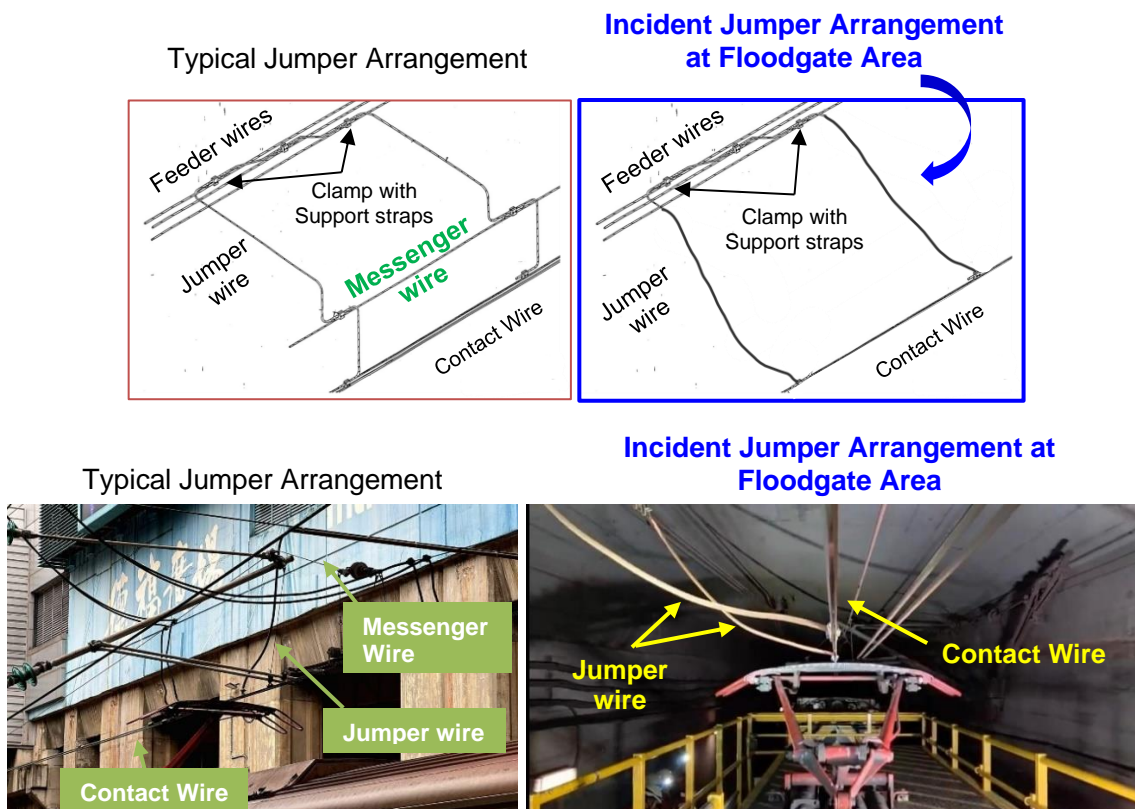
Figure 1: Illustration of Overhead Line Configuration

5.2.1 The overhead line configuration at the incident location, i.e. the tunnel floodgate section of QUB, adopts a special configuration with a short length of single contact wire designed for disconnection during floodgate closure whereas the other sections adopt typical arrangement of twin contact-wires design with a messenger wire above for suspension of the jumper wire.

5.2.2 For typical arrangement, the jumper wire connects the feeder wires and contact wire through messenger wires with adequate length to allow for thermal expansion without causing excessive sagging, and is secured by clamps and usually with additional support straps. For the overhead line configuration at the incident where a tunnel floodgate is located which would be lowered in case of emergency, the jumper wire is directly connected to the contact wire.

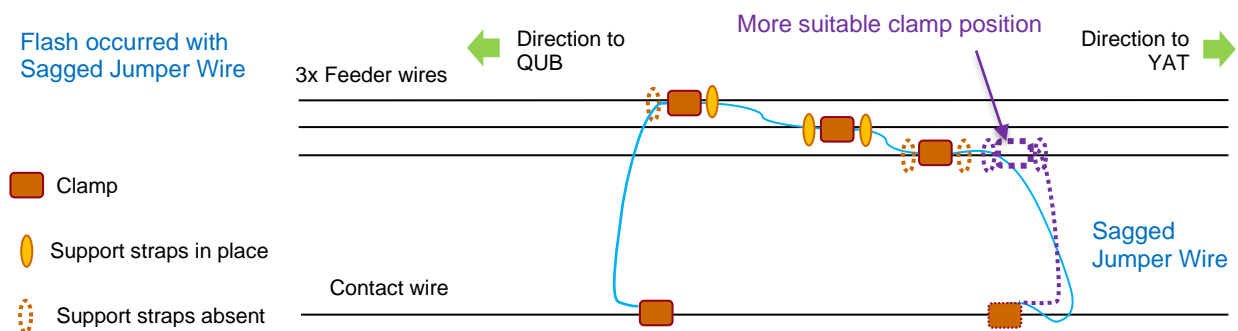
Figure 2: Illustration of the Sagged Jumper Wire

5.3.1 A section of an overhead line jumper wire at the incident location was found sagging below the contact wire level, showing signs of flashover having occurred and exhibiting broken and loosened strands. All clamps of the incident jumper wires were intact while 3 out of 6 support straps were not found present after the incident. Subsequent inspection found flashover marks on the roof of the incident train. Current protection device, namely DCCB, automatically tripped during the flashover.

- 5.3.2 A post incident site inspection of the affected jumper wire on the other hand revealed that the section of the jumper wire near QUB remained slightly above the contact wire, despite the absence of support strap. The jumper wire would remain above the contact wire, provided that the clamps were installed at more suitable locations as illustrated in Figure 2.

- 5.3.4 A new jumper wire with proper clamp position and reinforced support fixture was reinstated to the incident location in the immediate non-traffic hours. Subsequently, inspections were conducted at other locations adopting similar overhead line configuration near floodgate sections, including other operating lines. No abnormal sagging was observed, and the support fixtures for jumper wires at these locations were also reinforced as a precautionary measure.

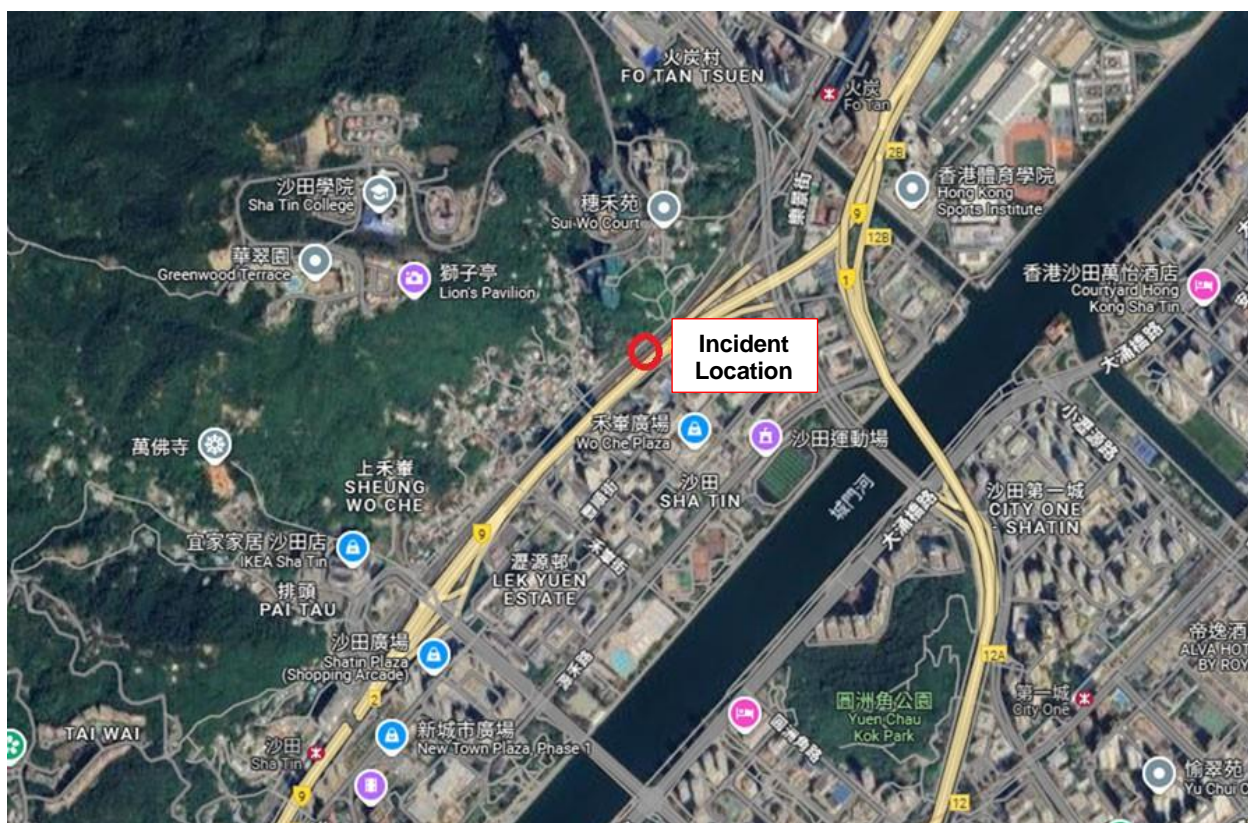
**Figure 1: Illustration of Incident Location**

- 1.1 At about 0344 hours on 27 April 2025, the Engineer's Person in Charge (EPIC) of the Engineering Possession for overhead line maintenance work between Sha Tin Station (SHT) and Fo Tan Station (FOT) of the East Rail Line (EAL) reported to the Operations Control Centre (OCC) that during the maintenance work, the elevating platform of the overhead line inspection vehicle (OIV) failed to be lowered after working at chainage A111.402. Recovery team arrived at the site and found that the lowering function of the elevating platform malfunctioned. As the railings on top of the elevating platform were in proximity to the overhead line, there was a need to handle it before moving the OIV. Recovery work was arranged immediately.

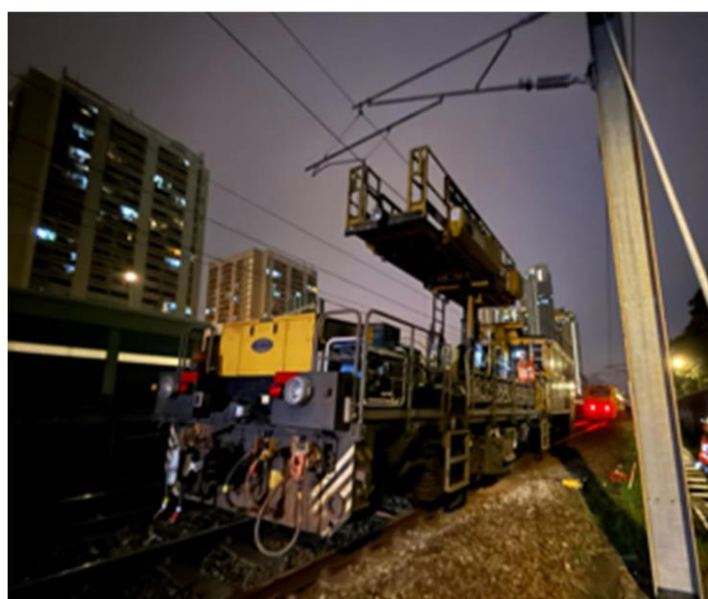
**Figure 2: The Incident Overhead Line Inspection Vehicle**

- 4.3 The incident OIV has been put into operation since 2009 (i.e. has been in use for 16 years) and is within its service life.

- 5.1.1 A technical investigation conducted after the incident found that a proportional distributor of the OIV was at fault. Simulation tests carried out verified that: when the faulty proportional distributor of the OIV was replaced with a new hydraulic proportional distributor, the OIV's elevation system functioned normally; on the other hand, when the faulty proportional distributor was installed on another working unit, the same failure symptoms were reproduced. Hence, it was confirmed that the incident was caused by a faulty proportional distributor.

- 5.1.2 A detailed inspection of the proportional distributor revealed the presence of milky fluid, metal particles, rust on the spool and valve body, fine scratch and worn marks on the spool, and deteriorated seals. According to the OEM, the milky fluid was the result of oil and water mixing, indicating contaminated hydraulic oil within the system.

- (a) To introduce new maintenance requirements for the hydraulic system<sup>2</sup> of the OIV. [Target completion: end July 2025]
- (b) To adopt the requirements stipulated in the OEM's manual to replace the hydraulic oil regularly with oil quality monitoring. [Target completion: end July 2025]

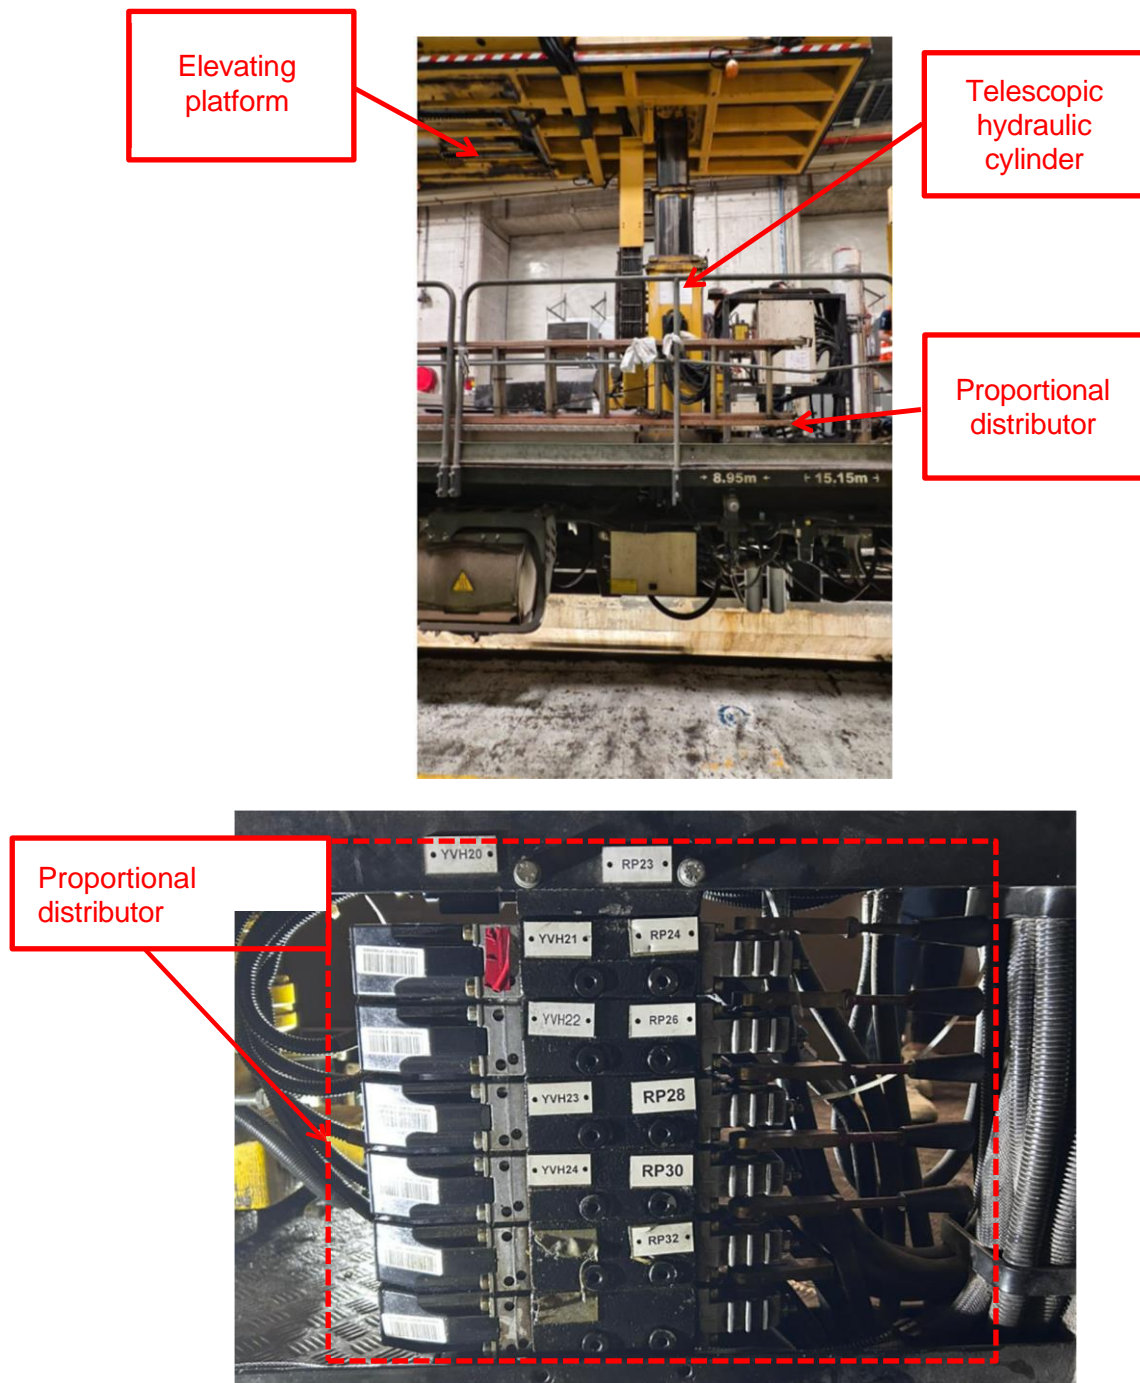
**Figure 3: Mechanism of the Elevating Platform**

- 4.1 The OIV is used for overhead line maintenance activities. It is equipped with an elevating platform for overhead line inspection and maintenance. The vertical movement of the elevating platform is powered by telescopic hydraulic cylinder, which is controlled by the proportional distributor.
- 4.2 The elevating platform can be operated via the in-cab or remote control during normal operations. According to the OEM manual, the elevating platform can be operated through electro-pump or hand pump together with the lever in the proportional distributor under emergency recovery.
