**MTR Strengthens Monitoring over Contractor of New Signalling System as Software Implementation Errors were Identified as Causes of Tsuen Wan Line Incident on 18 March 2019**

**Executive Summary**

### Incident of the New Signalling System Drill on Tsuen Wan Line on 18 March 2019

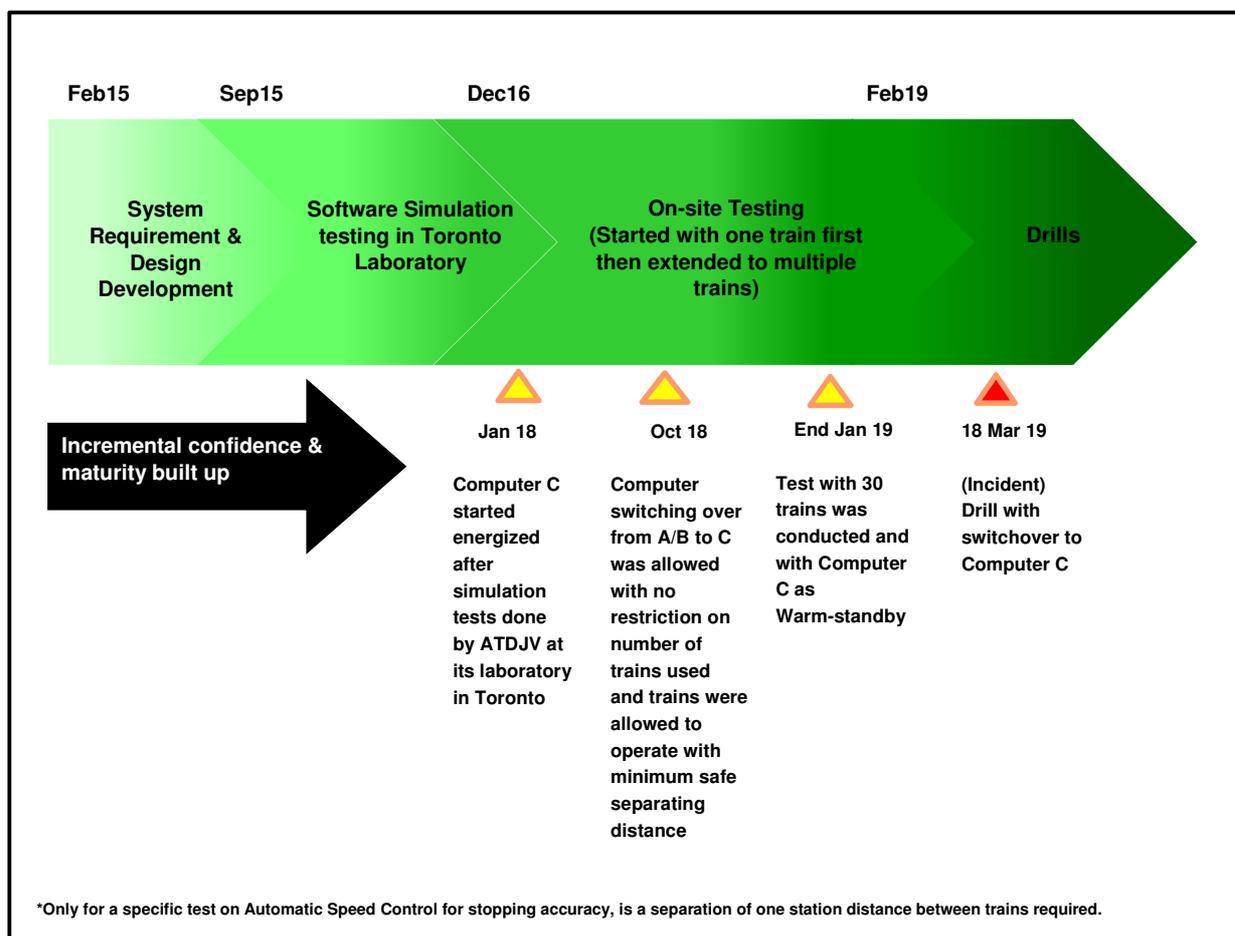
### Overall Programme of Simulations and Testing

1. ATDJV started on-site train testing during non-traffic hours on TWL in December 2016 and the scope of test was progressively extended from one train to multiple trains.
2. In January 2018, Computer C started to be energized as Warm-standby after simulation tests done by ATDJV at its laboratory in Toronto.
3. From 15 October 2018 onwards, in accordance with the safety documentation issued by ATDJV, computer switching over from A/B to C was allowed with no restriction on the number of trains used

4. In January 2019, while there was no restriction on the number of trains, full line testing with 30 trains and with Computer C as Warm-standby was conducted. In other words, Computer C could have taken the overall operational control in case both Computers A and B had failed.
