**MTR Announces  
Launch of East Rail Line New Signalling System and 9-car Trains on 6 February and  
a Series of Measures to Enhance Shatin to Central Link Project Control**

**Investigation Panel Report  
on Route Recall Issue**

**Date: 8 December 2020**

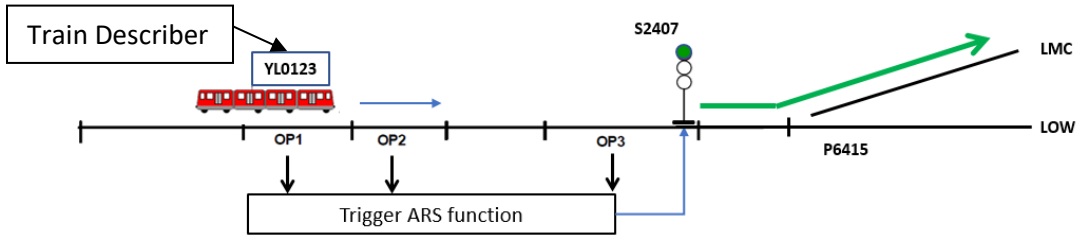
Train planned to Lok Ma Chau

Thereafter, the signal aspect would be turned to “Proceed” after route setting with conditions checked and completed by interlocking.

The TD would step forward as the physical train moves forward. As the train passes the signal, the signal aspect would be turned to Red and TD steps across the signal. The route set will be released as train passed the route.

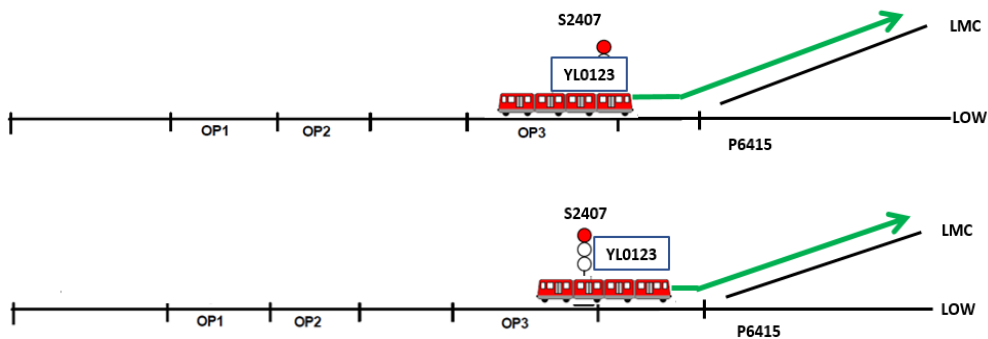
As the following train YM0125 approaches with Red signal aspect and no route ahead, automatic route setting for it will occur when its TD steps on OP1, leading to its own destination to LOW as defined by TD.
